# AN EXAMPLE OF HOW TO IMPROVE SAFETY AT SELECTED PEDESTRIAN CROSSINGS

SŁAWOMIR KOWALSKI<sup>1</sup>

## Abstract

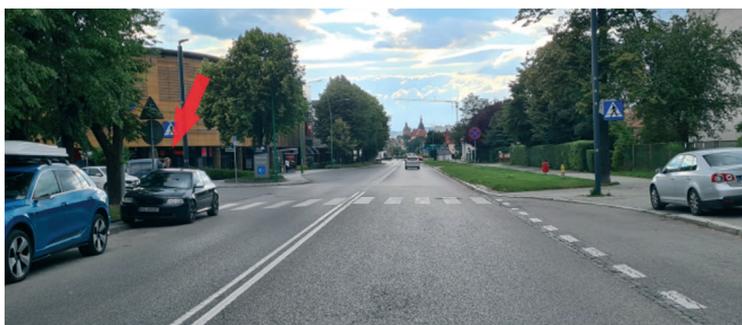
The first of the places under analysis is the pedestrian crossing located at Lwowska Street. This is a crossing near the junction with Heleny Modrzejewskiej Street. That street is one of the busiest roads in the town because of the direct connection with national roads DK-28 and DK-75 and because of a large shopping mall located in the area. There is a high risk of pedestrian incidents at that location due to limited visibility to both pedestrians and drivers. A sample photograph of that location with poor visibility to a pedestrian wishing to cross is shown in Figure 4. Visibility is often reduced by cars parked nearby, which limit the driver's field of vision. When cars are parked as shown in the figure, a driver travelling along Lwowska Street from the junction with national road No. 75 often notices the pedestrian at the very last moment and is forced to brake sharply. After dark or in unfavourable weather conditions, the visibility of a pedestrian entering that crossing decreases dramatically. In the picture, the pedestrian is marked with a red arrow.

**Fig. 4. A pedestrian crossing the road at the crossing located at Lwowska Street – the view from the driver's perspective**

In order to be noticed at that crossing, the pedestrian has to step out from behind the motionless car, which creates a dangerous situation on the road. Cars parked on the right also reduce the visibility of pedestrians who want to cross the road at that location. They cannot see whether a car is approaching from the right and often step out onto the roadway as shown in Figure 5 when assessing the situation on the road. Thus, the pedestrian is already on the crossing, so pursuant to the new regulations, the driver is obliged to give way to the pedestrian. In many cases, sudden braking takes place, which creates the risk of further cars crashing into each other.

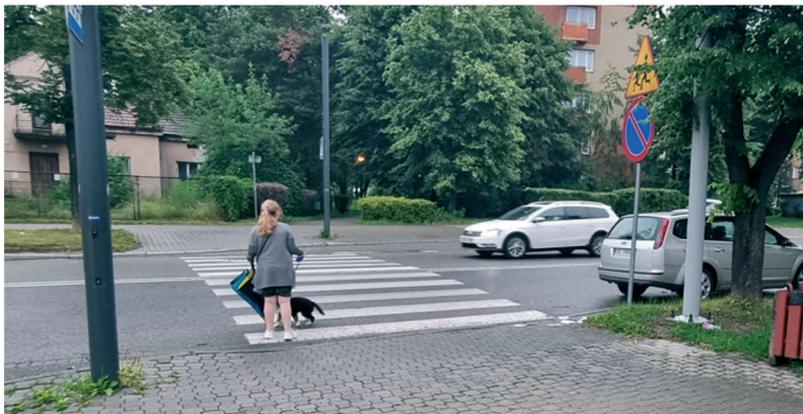
**Fig. 5. A pedestrian crossing the roadway at Lwowska Street**

As mentioned previously, that street is one of the busiest in the town and a large number of pedestrians cross the roadway there. The authors' observations show that every tenth car stopping in front of the crossing has to brake sharply because the driver notices a pedestrian crossing the road at the very last moment. From the pedestrian's perspective, visibility is reduced, too, and the pedestrian cannot see vehicles coming from the right.

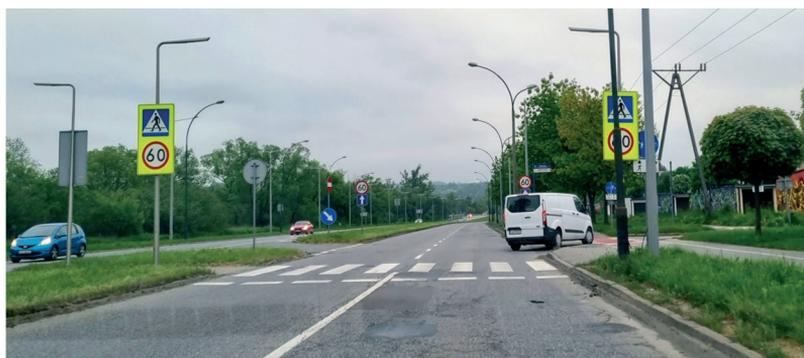
The second location analysed in this article is the pedestrian crossing located at Aleje Piłsudskiego (Figure 6). This is a dual carriageway with national road DK-75 running along. At the avenue, car, bicycle and pedestrian traffic is heavy. The road is a section of the route to Krynica-Zdrój and Slovakia. There are also shops and a housing estate in the area. The speed limit at the road section under analysis is 60 km/h. The pedestrian crossing under analysis is well signposted. Pedestrian crossing and speed limit signs are placed on reflective boards. Pedestrian safety at that location may, however, be at a greater hazard than at other crossings due to the factors mentioned previously, so completing the crossing with mechatronic systems would be a good solution.

**Fig. 6. A pedestrian crossing at Aleje Piłsudskiego as seen from the driver's perspective**

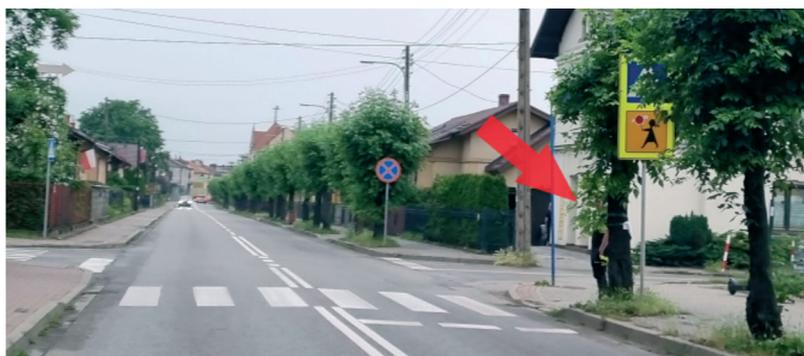
The third pedestrian crossing discussed in this article is the crossing located at Zygmuntowska Street. That street runs within the DK-87 national road leading to, including other places, Piwniczna-Zdrój and Slovakia; therefore vehicle traffic at that place is busy, particularly during rush hours. It is also noticeable that of children using the nearby primary school. Thick traffic is also generated on Sundays. As a church attended by worshippers from all over the town and surrounding areas is also located at that street. That crossing appears to be unsafe due to certain infrastructure elements that may impede visibility to both drivers and pedestrians. Figure 7 shows the pedestrian crossing from the driver's perspective, with a pedestrian waiting to cross (red arrow). Figure 8, on the other hand, shows the same crossing, but from the perspective of a pedestrian assessing the situation on the road on his or her left side. The pedestrian standing on the other side of the street is also poorly visible, especially during the rush hour, as they are obscured by a line of cars waiting to drive onto the nearby junction. The pedestrian there has limited visibility and only assesses the situation at the other lane once he or she has entered the centre of the roadway.

**Fig. 7. The pedestrian crossing at Zygmuntowska street as seen from the driver's perspective**

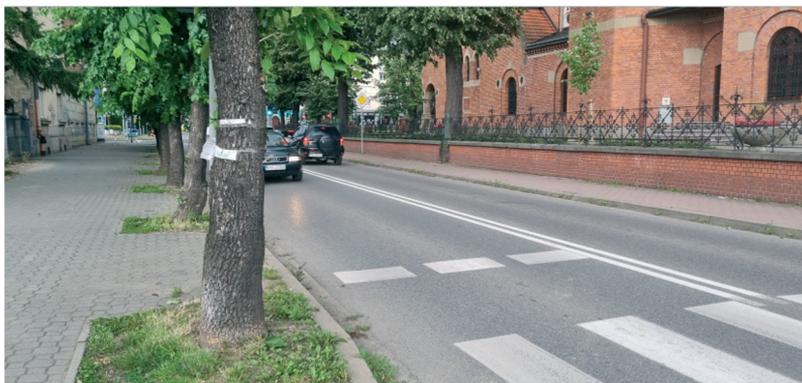
Fig. 8. A pedestrian crossing at Zygmuntowska street as seen from the pedestrian's perspective

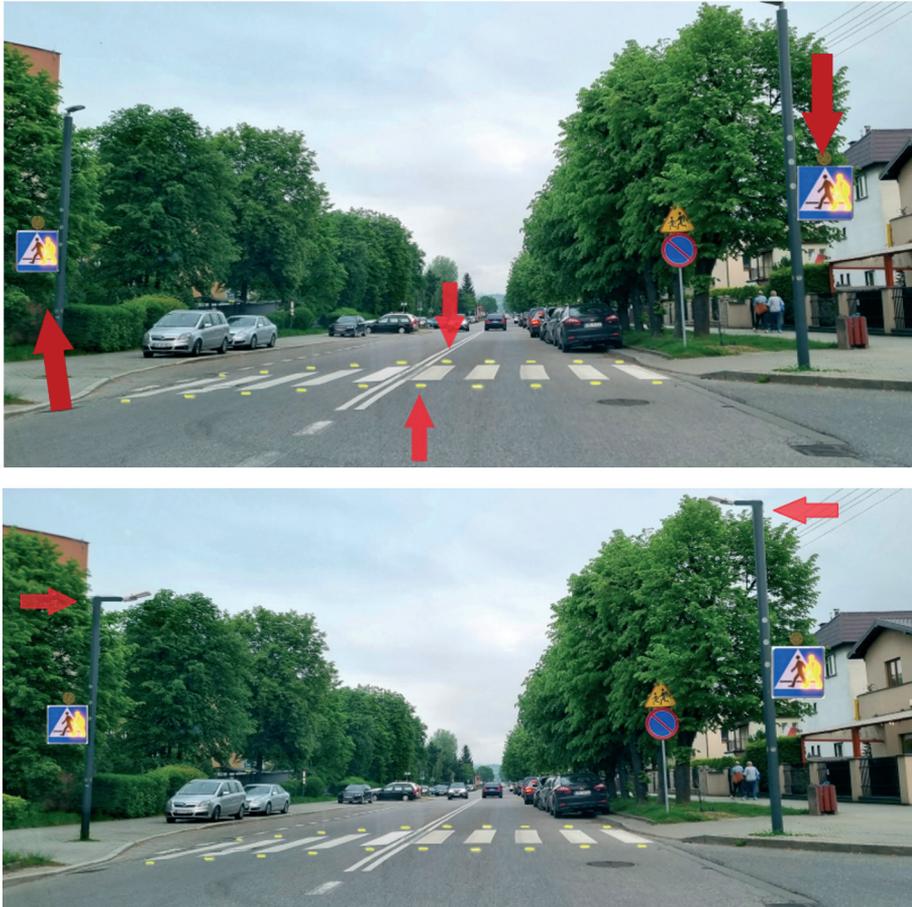
These road signs could be completed with reflective elements or LED lights, the so-called cat's eyes, embedded in asphalt along the zebra. After dark, these elements will highlight the pedestrian crossing line by shining white or yellow. The LED lights, however, will blink when a pedestrian appears by the crossing. The visualisation of the pedestrian crossing at Lwowska Street with the use of mechatronic systems is shown in Figure 16. It is also possible to install those.

**Fig. 16. The visualisation of the pedestrian crossing at Lwowska Street with the use of mechatronic systems**

The selected pedestrian crossing has lamps which illuminate the crossing. However, if a smart crossing module is used, the replacement of the existing lamps with motion detectors providing extra light at the crossing would be a good solution. Active crossing illumination is one of the most important elements increasing safety at the crossing. The system becomes

active after dark. Detectors are activated as soon as a pedestrian approaches the crossing. Owing to the installed motion detectors, the detectors shine at 100 per cent of their capacity. An important feature of the crossing light module is that it adjusts the lights in such a way that they do not dazzle the driver, but only improve visibility to the driver after dark. The use of that type of solution at the Lwowska Street crossing will significantly improve the safety of pedestrians who wish to cross the road at that place.

The proposed solution for improving the visibility of the pedestrian crossing as well as of the pedestrian himself or herself can be completed with a sound system informing the pedestrian about the crossing which a pedestrian approaches. Owing to sound modules which trigger messages of any content, these modules will definitely influence the pedestrian's attention. The system will be particularly useful for pedestrians who stare at their mobile phone screens, but also for the visually impaired. The audible message will certainly take the pedestrian's eyes off his or her phone and draw their attention to what is happening around him or her.

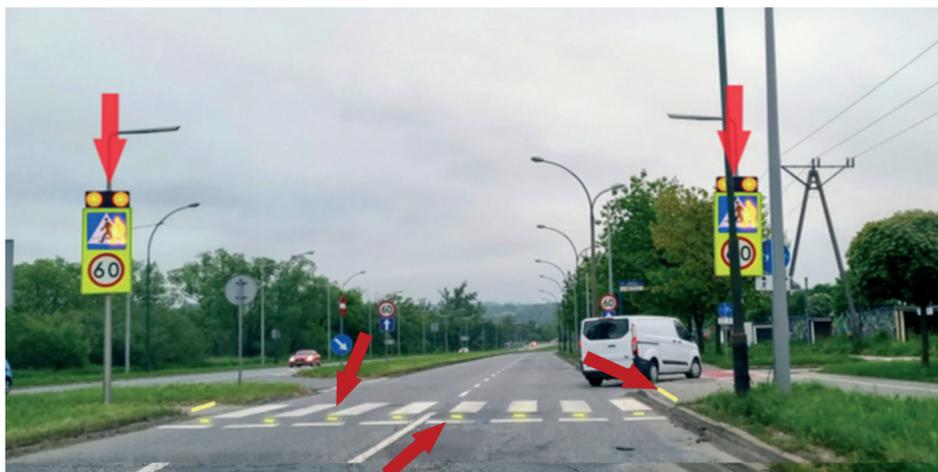
Similar solutions may be adopted at the pedestrian crossing located at Aleje Piłsudskiego. The crossing located there is particularly dangerous due to its location on a dual carriageway with a higher speed limit of 60 km/h, which is why extra elements were used in addition to the system described in the previous case. Figure 17 shows the visualisation of the pedestrian crossing at Aleje Piłsudskiego with the use of mechatronic systems.

**Fig. 17. The visualisation of the pedestrian crossing at Aleje Piłsudskiego with the use of mechatronic systems**

The mechatronic system highlighting the pedestrian crossing at that location consists of four elements. The first one is spot active LED reflective elements powered by photovoltaic panels. Those elements delineate the pedestrian crossing line, so drivers will have time to slow down or stop. The elements will activate when a pedestrian approaches the crossing. That solution is particularly important for drivers in the inner lane, whose view to the right side of the crossing is obstructed by cars moving by. The second element of the mechatronic system is an active pedestrian crossing information sign [D-6]. A walking man on the sign will change his position in parallel to the pulsating LED lights embedded in asphalt. The third element built into that pedestrian crossing are the pulsators placed above the D-6 sign. The pulsators are intended to warn drivers approaching the pedestrian crossing and make them exercise greater caution. The pulsators are activated when the microwave sensor detects an approaching pedestrian. The fourth component of the system are the S-Line active strips installed at the threshold of the pedestrian crossing. The strips can change the colour depending on the presence of a vehicle near the crossing. The strip will shine yellow if there is no car nearby and red if a vehicle is approaching the crossing. Loudspeakers may also be installed to inform the pedestrian of the situation on the roadway.

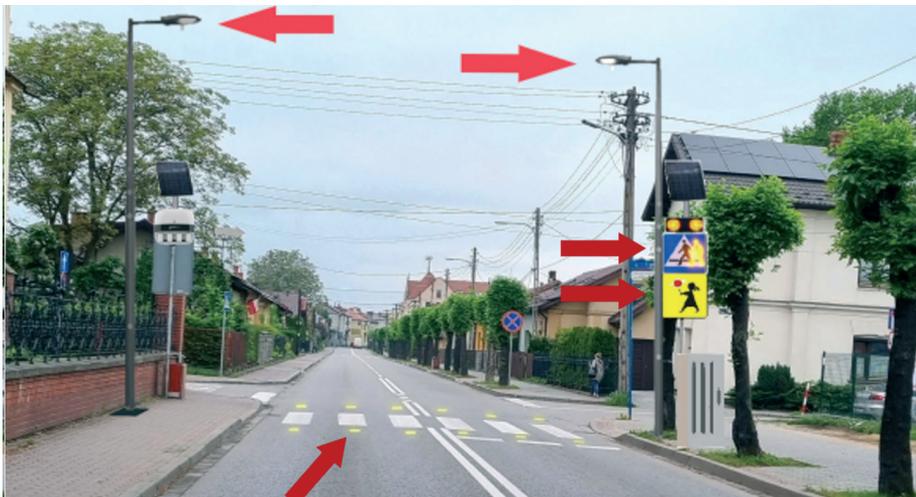
At the third pedestrian crossing under consideration, the previously used mechatronic system could also be applied using the infrastructure already present at that location. As there is a primary school nearby, additional interactive signs may be used to inform drivers about the school, as well as sound amplification systems may be used for pedestrians, especially children, to inform them about approaching vehicles. Figure 18 shows the visualisation of the pedestrian crossing at Zygmuntowska Street with the use of mechatronic systems.

**Fig. 18. The visualisation of the pedestrian crossing at Zygmuntowska Street with the use of mechatronic systems**

As mentioned in the initial part of the article, the pedestrian crossing under analysis is one of the difficult ones because the pedestrian cannot be seen from a greater distance. Heavy traffic during peak hours and on Sundays, as well as certain elements of the road infrastructure, contribute to this condition. Therefore, the use of the systems shown in the figure above will ensure full safety at that location. School children and the elderly and visually impaired will also be able to feel safe due to the option to use systems informing about the current situation on the road.

It is possible to install a dedicated mechatronic system on the elements of current infrastructure, which will reduce installation costs. Spot reflective elements fitted in the roadway are provided with photovoltaic panels and a 1200 mAh battery, which enables 72-hour operation and does not require an additional power source. Such a solution is not only environmentally friendly (because PV panels do not produce harmful CO<sub>2</sub>), but also cost-effective, and increases pedestrian crossing safety, too. When seeing flashing lights, a driver will slow down to make sure no pedestrian is approaching the crossing. Interactive D-6 road signs, one on either side of the road, can also be installed. That system can also be powered by 20 W photovoltaic panels, which it is possible to install above the sign. That sign effectively draws the driver's attention with flashing LED lights. Owing to that, the driver will notice a pedestrian who wants to cross the road at the selected place. The aforementioned elements of the system can be completed with pedestrian crossing lamps with LED bulbs, which produce stronger light than traditional lamps and are cheaper to operate.
