# EXPERIMENTAL RESEARCHES OF SAFETY OF ARMoured PERSONNEL CARRIER CREW DURING COLLISION WITH OBSTACLE

## Summary

The paper presents problems related to dynamic loads of armoured personnel carriers design as well as soldiers located inside them. In order to assess the exposure of soldiers while overcoming terrain and engineering obstacles experimental studies were performed covering a carrier's collision with a concrete obstacle. The scope of the tests included a collision of the armoured personnel carrier with obstacle for two speeds: 6 and 12 km/h. During crash tests, anthropomorphic measurement equipment – Hybrid III 50th Male Dummy type – was used for recording the values of loads affecting the soldiers. During crash tests, two fast video cameras were used for recording motion of the carrier and obstacle's plates. The vehicle body accelerations were recorded as well. In the paper the research conditions and used measurement equipment were described. Some results of experimental studies were presented. Typical phases of motions of dummies located in driving and landing troop compartment were presented. The values of the carrier's body accelerations in driving and landing troop

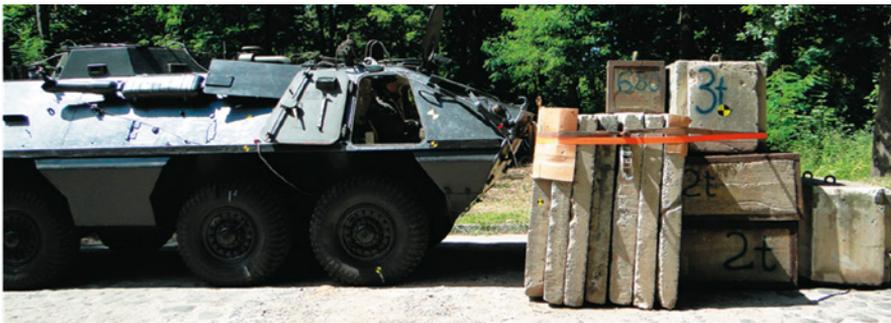
Fig. 1. APC SKOT and concrete obstacle before test

Fig. 1 presents a view of a concrete obstacle and a personnel carrier prepared for a crash test. The obstacle consisted of twelve elements: seven plates and five concrete blocks. The face of the barrier measured 1.5 x3m. Total mass of the obstacle was 19 780 kg, whereas mass of the vehicle prepared for attempts was 12 200 kg.

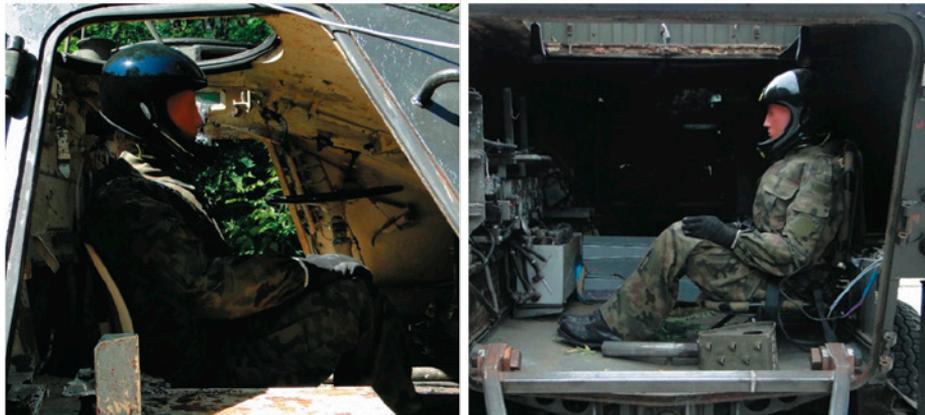
During crash tests, anthropomorphic measurement equipment – Hybrid III 50<sup>th</sup> Male Dummy [5] type – was used for recording the values of loads affecting the soldiers. 50-centile male test dummy Hybrid III is the most common dummy used in the automotive industry. It is used to evaluate the safety and structure. It allows for acquisition of physical values truly reflecting a possible influence on a human body. That kind of equipment is basically designed for frontal car crash tests. A dummy located in the driver compartment was placed on a standard seat of the SKOT vehicle, without a headrest, and fastened with four-point seat belts. A dummy located in the landing troop was placed on a seat making standard equipment for aAPCRosomak and it was fastened with a lap belt. (fig. 2).

**Fig. 2. A dummy located in the driver compartment (left) and in the landing troop compartment (right)**

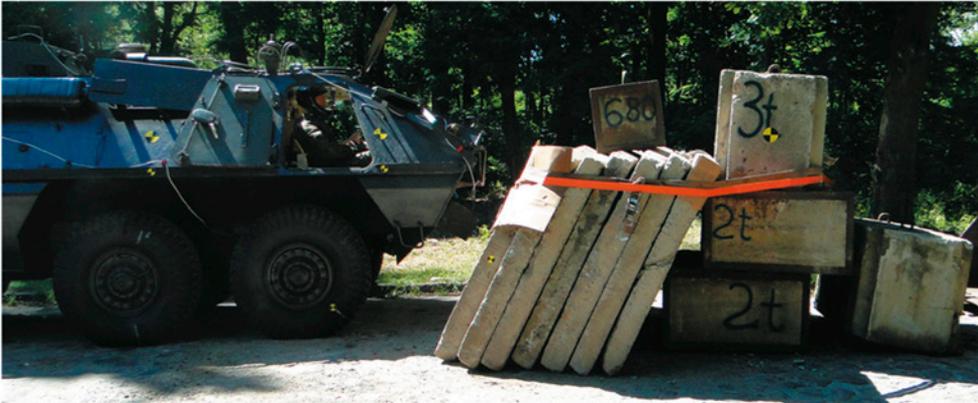
On fig. 5. the test vehicle and a barrier were presented after collision. A lean and displacement of individual concrete blocks was different for individual attempts.

**Fig. 5. The concrete obstacle after collision ( $v = 12,10$  km/h)**

For smaller impact velocities an angular displacement of concrete slabs amounted  $3^\circ$  and simultaneously its translation for about 1,5 cm occurred. Concrete blocks behind slabs were translated for about 10 cm. For comparison in attempt 5 these slabs were turned for angle  $27^\circ$  and the lower and upper blocks behind them were moved respectively for 26 cm and 53 cm. Moreover, for the attempt no. 4 and 6 first seven plates were rotated with regard to a vertical axis. For this reason, a measurement and comparison of results for individual blocks was difficult.

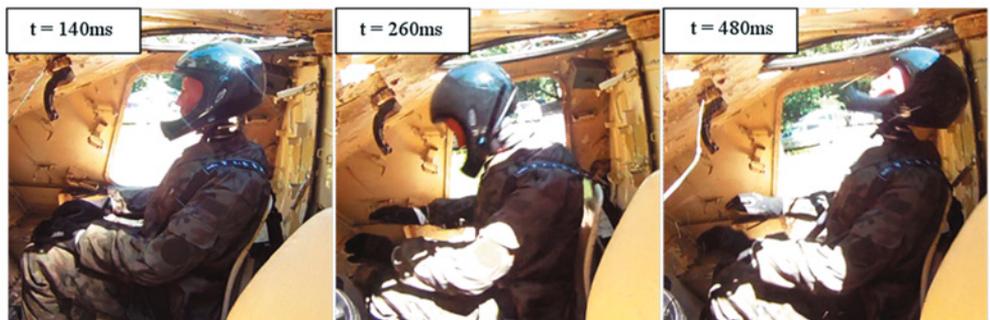
Fig. 7 presents three phases of motion of the dummy located in the driver's compartment. After 120 ms from the impact, the maximum bending of the dummy's neck occurs. Due to the use of a four-point seat belt, motion of the whole body is significantly limited. Only motion of the head and shoulders is visible. After 340 ms the body bends backwards which is characteristic for frontal collisions. The body is stopped on the backrest of the seat, while the head, in case of no head restraint, strongly tilts backwards.

Fig. 7. Phases of motion of the dummy located in the driver's compartment (trial no. 5)

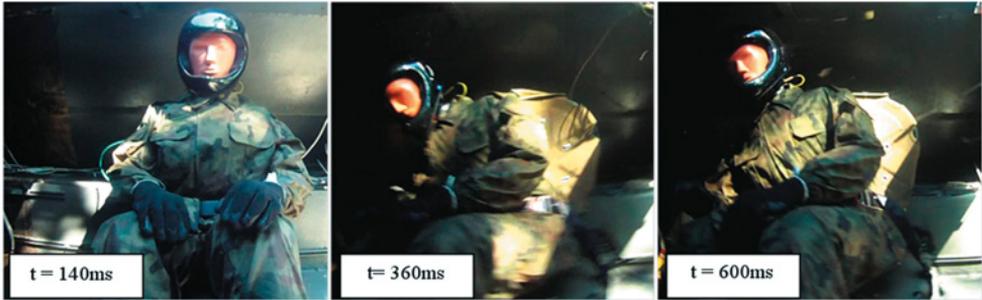
Different behaviour can be observed for a dummy located in the landing troop compartment (fig. 8). The dummy is placed on a seat located crosswise towards direction of motion and it is protected with just a lap belt. In about 220 ms from the moment of impact the maximum dummy displacement can be observed. Due to the fact that the pelvis is held by the belt, the body and the heads bend to the right side with simultaneous bending forward and a slight turn against the vertical axis. After the impact, the dummy does not fully return to its initial position and stops after about 460 ms.

**Fig. 8. Phases of motion of the dummy located in the landing troop compartment (trial no. 5)**
