# EXPERIMENTAL RESEARCHES OF SAFETY OF ARMoured PERSONNEL CARRIER CREW DURING COLLISION WITH OBSTACLE

The paper presents problems related to dynamic loads of armoured personnel carriers design as well as soldiers located inside them. In order to assess the exposure of soldiers while overcoming terrain and engineering obstacles experimental studies were performed covering a carrier's collision with a concrete obstacle. The scope of the tests included a collision of the armoured personnel carrier with obstacle for two speeds: 6 and 12 km/h. During crash tests, anthropomorphic measurement equipment – Hybrid III 50th Male Dummy type – was used for recording the values of loads affecting the soldiers. During crash tests, two fast video cameras were used for recording motion of the carrier and obstacle's plates. The vehicle body accelerations were recorded as well. In the paper the research conditions and used measurement equipment were described. Some results of experimental studies were presented. Typical phases of motions of dummies located in driving and landing troop compartment were presented. The values of the carrier's body accelerations in driving and landing troop compartment

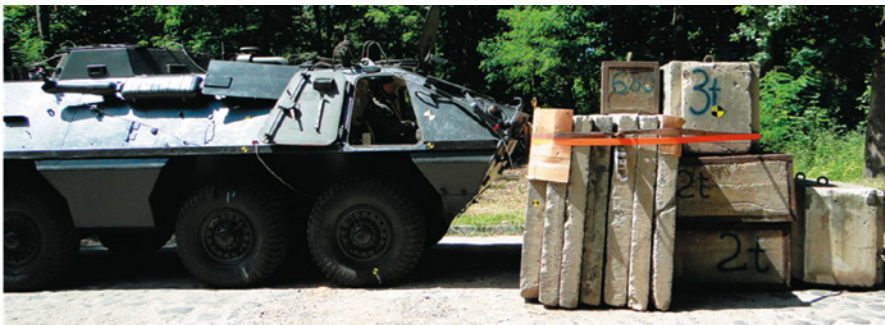
Fig. 1. APC SKOT and concrete obstacle before test

Fig. 1 presents a view of a concrete obstacle and a personnel carrier prepared for a crash test. The obstacle consisted of twelve elements: seven plates and five concrete blocks. The face of the barrier measured 1.5 x 3m. Total mass of the obstacle was 19 780 kg, whereas mass of the vehicle prepared for attempts was 12 200 kg.

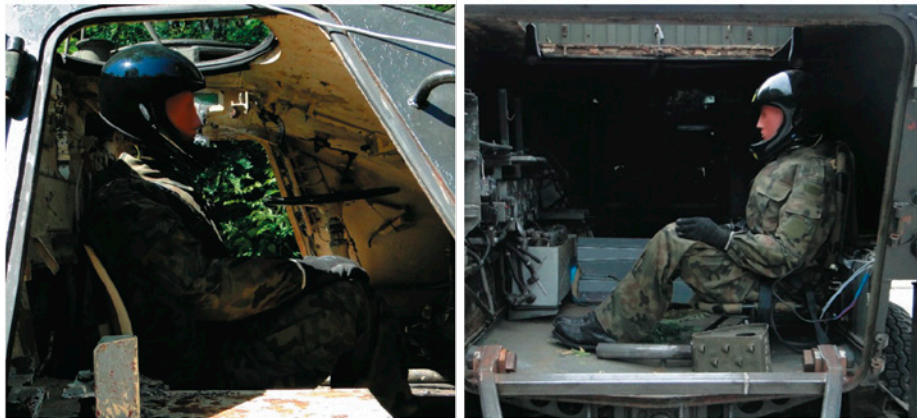
During crash tests, anthropomorphic measurement equipment – Hybrid III 50<sup>th</sup> Male Dummy [5] type – was used for recording the values of loads affecting the soldiers. 50-centile male test dummy Hybrid III is the most common dummy used in the automotive industry. It is used to evaluate the safety and structure. It allows for acquisition of physical values truly reflecting a possible influence on a human body. That kind of equipment is basically designed for frontal car crash tests. A dummy located in the driver compartment was placed on a standard seat of the SKOT vehicle, without a headrest, and fastened with four-point seat belts. A dummy located in the landing troop was placed on a seat making standard equipment for aAPCRosomak and it was fastened with a lap belt. (fig. 2).

**Fig. 2. A dummy located in the driver compartment (left) and in the landing troop compartment (right)**

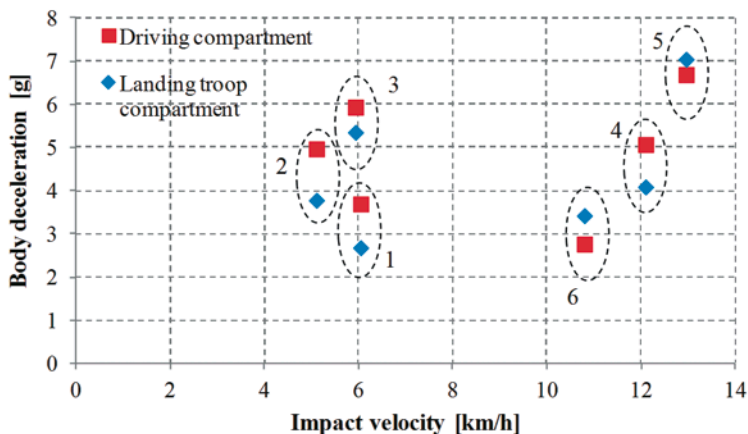
Table 1 specifies, defined on the basis of analysis of the records from the fast video cameras, real impact speeds and recorded maximum body deceleration values in the driving and landing troop compartment for individual trials. Obtained results are illustrated on fig. 4.

Higher homogeneity of obtained results can be observed for lower impact velocities (trials 1-3), however a close relation between velocity and deceleration has not been obtained. It was mainly caused by the lack of the repetitiveness in relation to the point of the collision and the structure of the obstacle (despite its reconstruction after every attempt). At the final stage of motion the carrier did not always move perpendicularly towards the frontal surface of the barrier. In most cases, of maximum values of decelerations in the landing troop compartment were smaller than in the driving compartment.

Much higher dispersion in obtained results was observed for trials 4-6. Increased velocity negatively affects a possibility of directing the carrier on the obstacle. In case of attempt 4 the carrier hit the obstacle about 2/3 of its frontal plate, whereas for attempt 6 only 1/3 its frontal plate. A different motion of the barrier was noticed. Apart from its tilting, considerable rotation about a vertical axis took place as well. As a result, a stopping distance was extended and significant reduction of maximal values of decelerations was observed.

Fig. 4. The distribution of maximum body deceleration

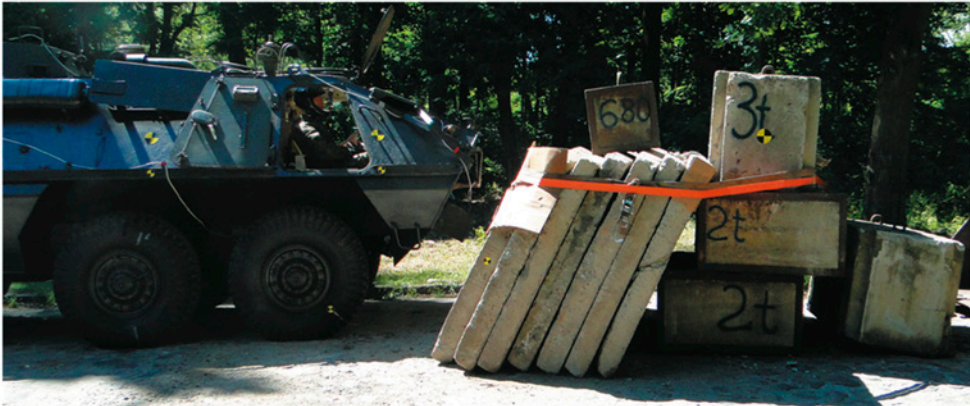
On fig. 5. the test vehicle and a barrier were presented after collision. A lean and displacement of individual concrete blocks was different for individual attempts.

**Fig. 5. The concrete obstacle after collision ( $v = 12,10$  km/h)**

For smaller impact velocities an angular displacement of concrete slabs amounted  $3^\circ$  and simultaneously its translation for about 1,5 cm occurred. Concrete blocks behind slabs were translated for about 10 cm. For comparison in attempt 5 these slabs were turned for angle  $27^\circ$  and the lower and upper blocks behind them were moved respectively for 26 cm and 53 cm. Moreover, for the attempt no. 4 and 6 first seven plates were rotated with regard to a vertical axis. For this reason, a measurement and comparison of results for individual blocks was difficult.

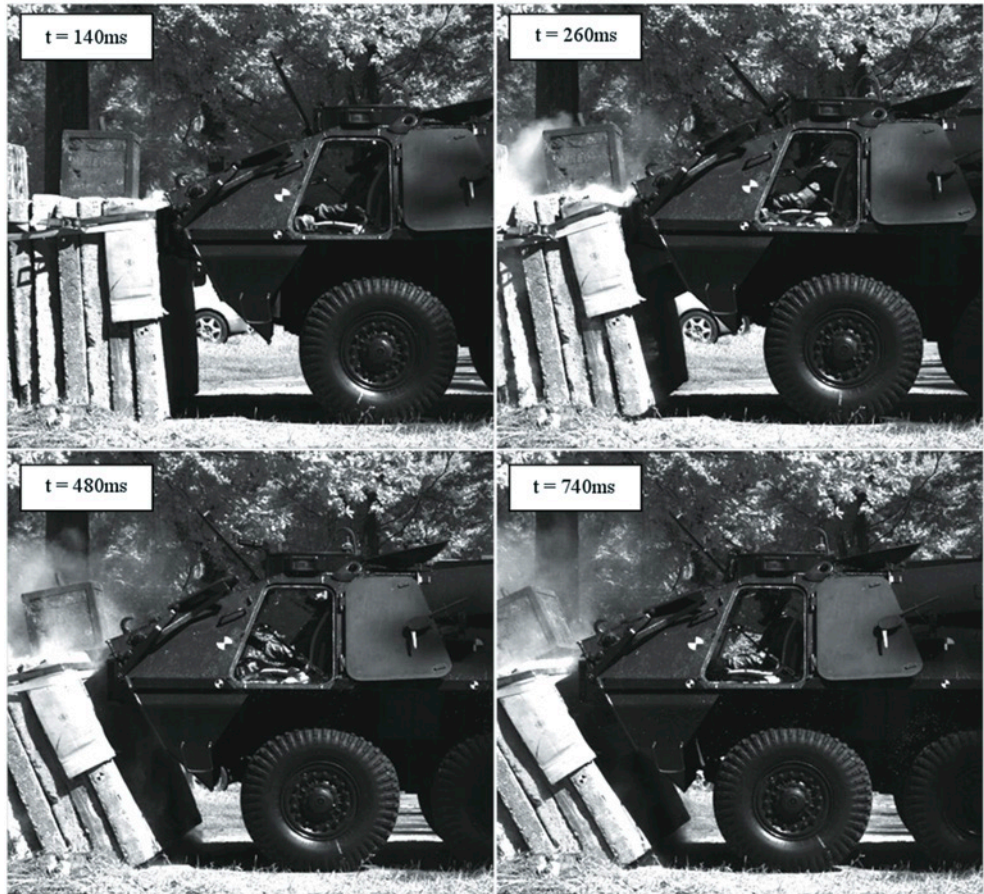
Fig. 6 specifies chosen phases of collision with a concrete obstacle for a trial no. 5. The impact took place at 140 ms of the measurement time (according to the courses on fig. 3 and 9). An incremental lean of concrete plates is visible on it. The carrier was stopped after about 600 ms from the moment of impact.

Fig. 6. Phases of APC collision with a concrete obstacle (trial no. 5)

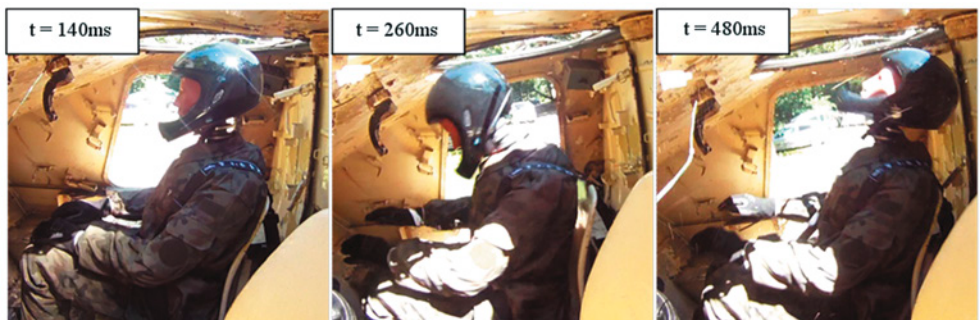
Fig. 7 presents three phases of motion of the dummy located in the driver's compartment. After 120 ms from the impact, the maximum bending of the dummy's neck occurs. Due to the use of a four-point seat belt, motion of the whole body is significantly limited. Only motion of the head and shoulders is visible. After 340 ms the body bends backwards which is characteristic for frontal collisions. The body is stopped on the backrest of the seat, while the head, in case of no head restraint, strongly tilts backwards.

Fig. 7. Phases of motion of the dummy located in the driver's compartment (trial no. 5)

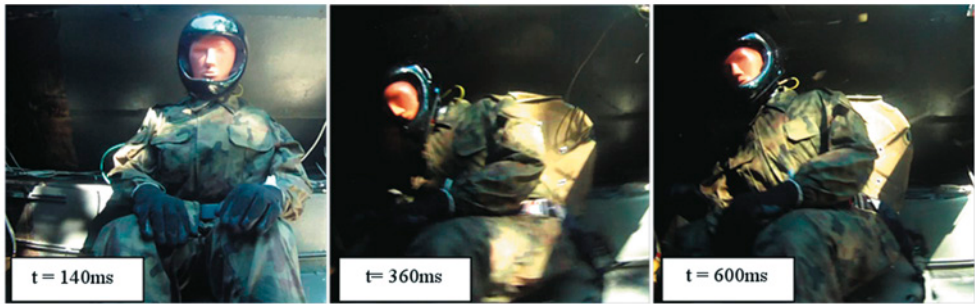
Different behaviour can be observed for a dummy located in the landing troop compartment (fig. 8). The dummy is placed on a seat located crosswise towards direction of motion and it is protected with just a lap belt. In about 220 ms from the moment of impact the maximum dummy displacement can be observed. Due to the fact that the pelvis is held by the belt, the body and the heads bend to the right side with simultaneous bending forward and a slight turn against the vertical axis. After the impact, the dummy does not fully return to its initial position and stops after about 460 ms.

**Fig. 8. Phases of motion of the dummy located in the landing troop compartment (trial no. 5)**
